LITTLE NACHES RIVER PASSAGE PROJECT

Annual Report FY90 and FY89

Annual Report FY89

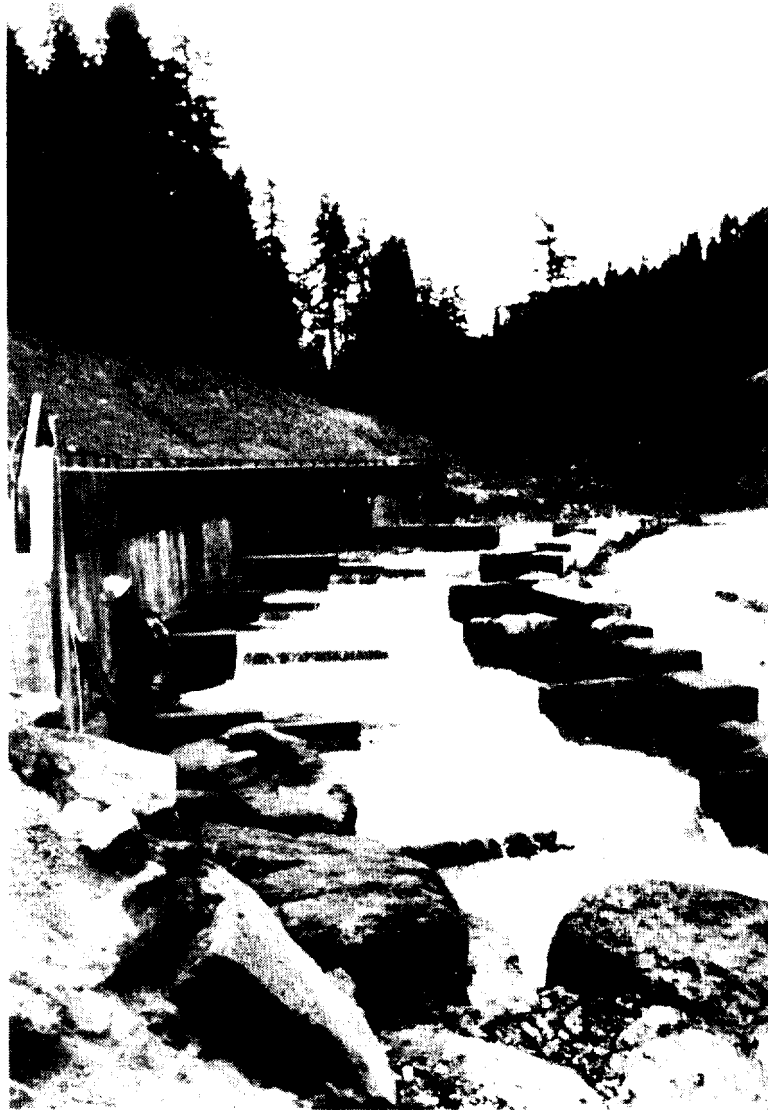
SALMON FALLS FISHLADDER
400 CFS MAY 27, 1988

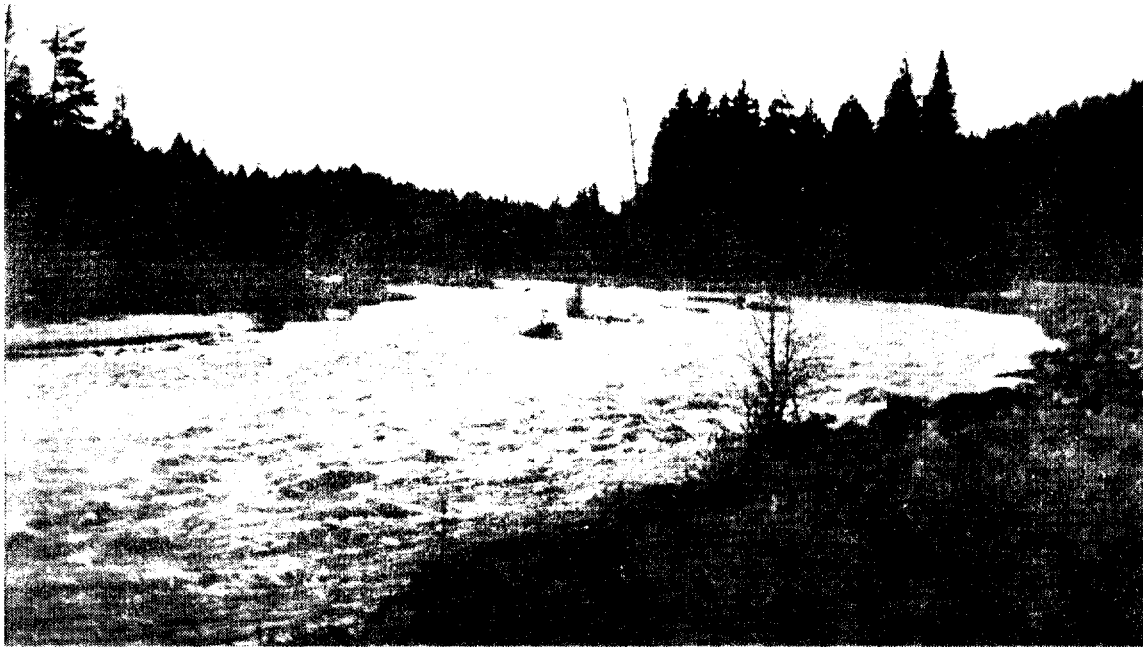
RANDOM ROCKS 1 VICINITY
30 CFS AUGUST 24, 1989

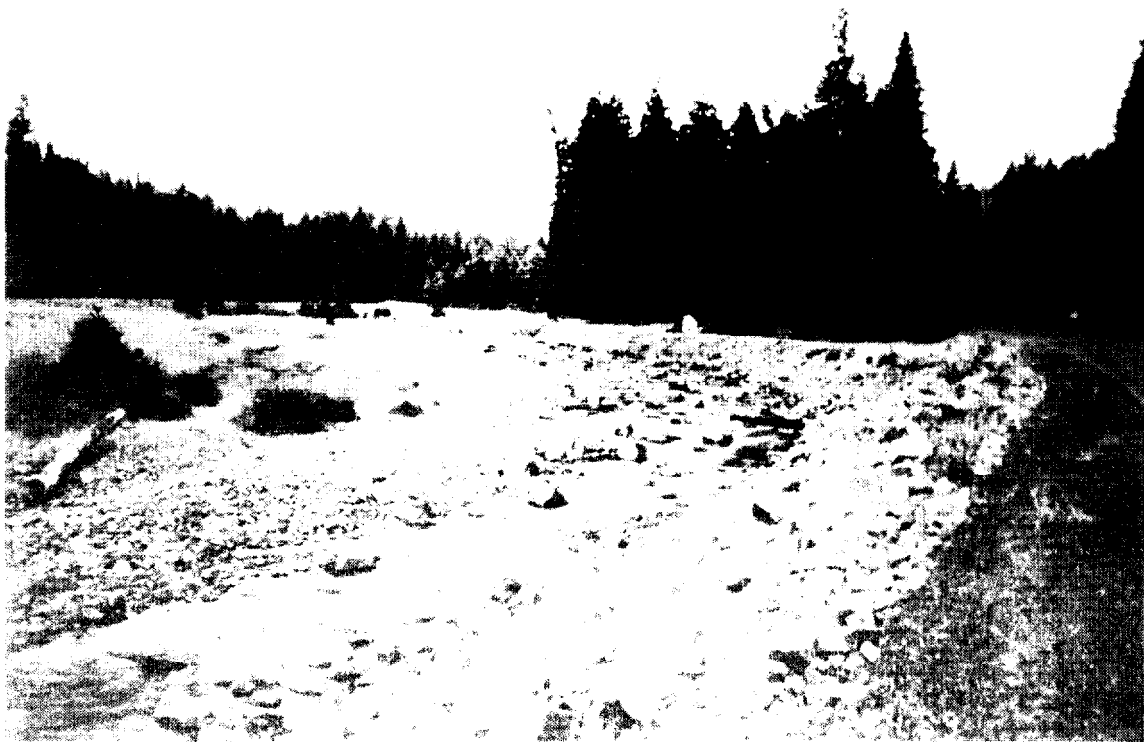
The flood event in November 1990 changed the above assessment dramatically. All of the log weirs are gone. Clusters of large rocks are still visible, especially near the log and rock weir keyways. Other than that, most of the rock weirs are completely gone or sufficiently altered in shape so that they no longer perform their designed function. Increased braiding of the river on the flood plain may produce alternate main channels. Passage problems are anticipated in several locations during 1991 summer low flows. A request for flood relief funding for the needed repairs has been made, but no response has been received to date.

RANDOM ROCKS 1 VICINITY
FLOOD EVENT NOVEMBER 25, 1990

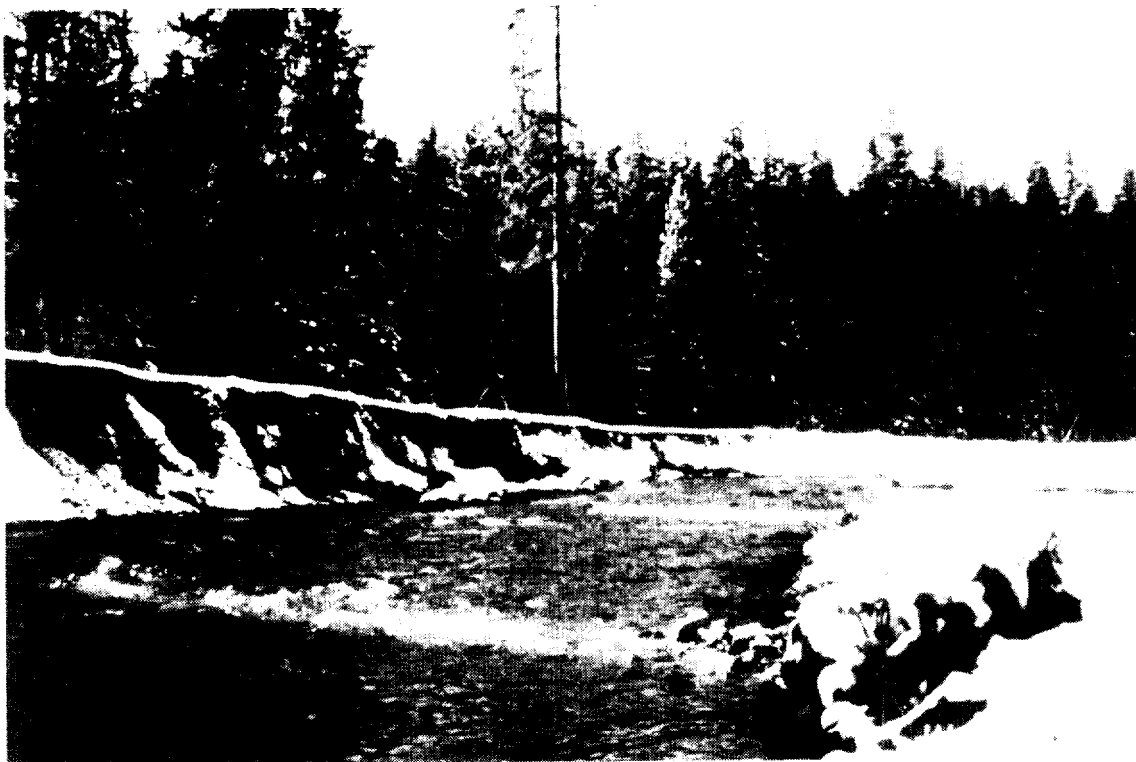
- 2) LOG SILLS- The channel cross sections appear unchanged over the last four years, except the 1989 and 1990 elevations are approximately a foot lower than the 1988 and 1987 elevations. This is most likely an error in the 1989 field notes, as this portion of the channel does not visually appear to have changed much since the structure was installed in 1986 (1990 starting elevation was generated from the mistaken 1989 elevation). The last four springs have not produced large enough flood events to cause any significant channel changes. The recent November 1990 flood exposed the previously buried downstream-most log sill, and stream channel braiding was greatly increased in this area and downstream.

UPSTREAM FROM LOG SILLS AFTER FLOOD EVENT
180 CFS DECEMBER 6, 1990
EROSION, ESPECIALLY ON RIGHT BANK

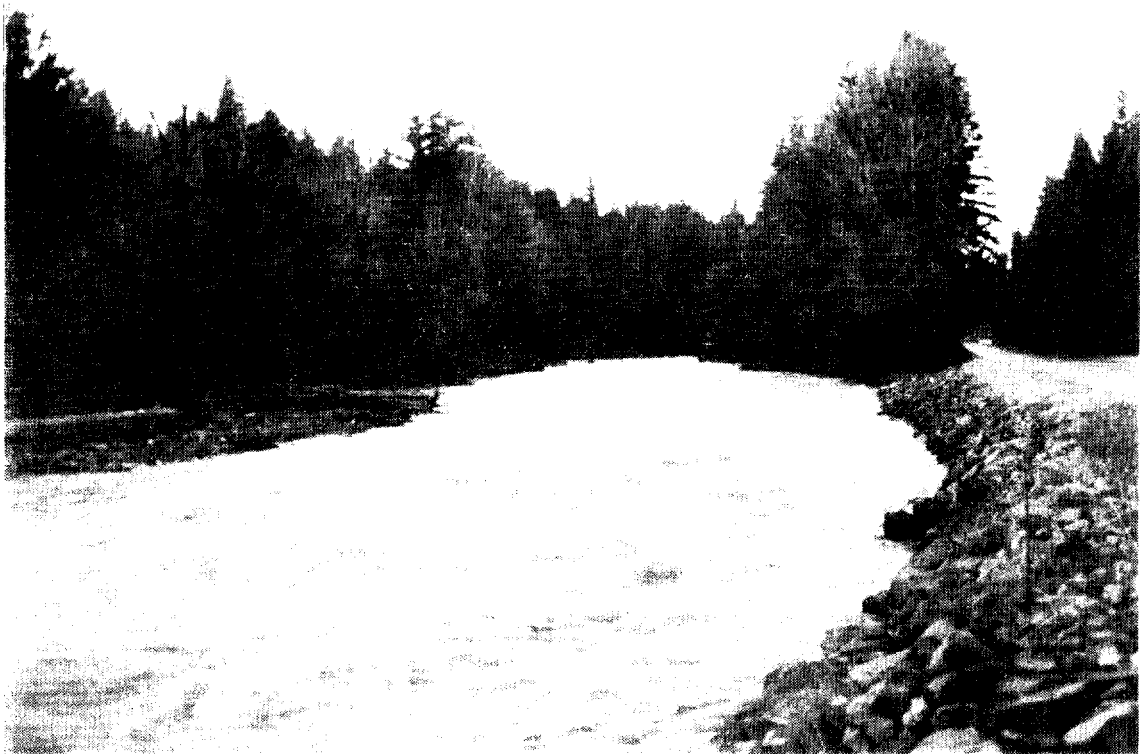
- 4) ROCK TRIOS- The channel cross sections appear unchanged over the last four years. The headcut in the downstream area of the log weirs moved up to the rock trio transects area during the November flood. The

overflow channel around the log weir location appears to have increased in size also.

UPSTREAM FROM ROCK TRIOS
FLOOD EVENT NOVEMBER 25, 1990

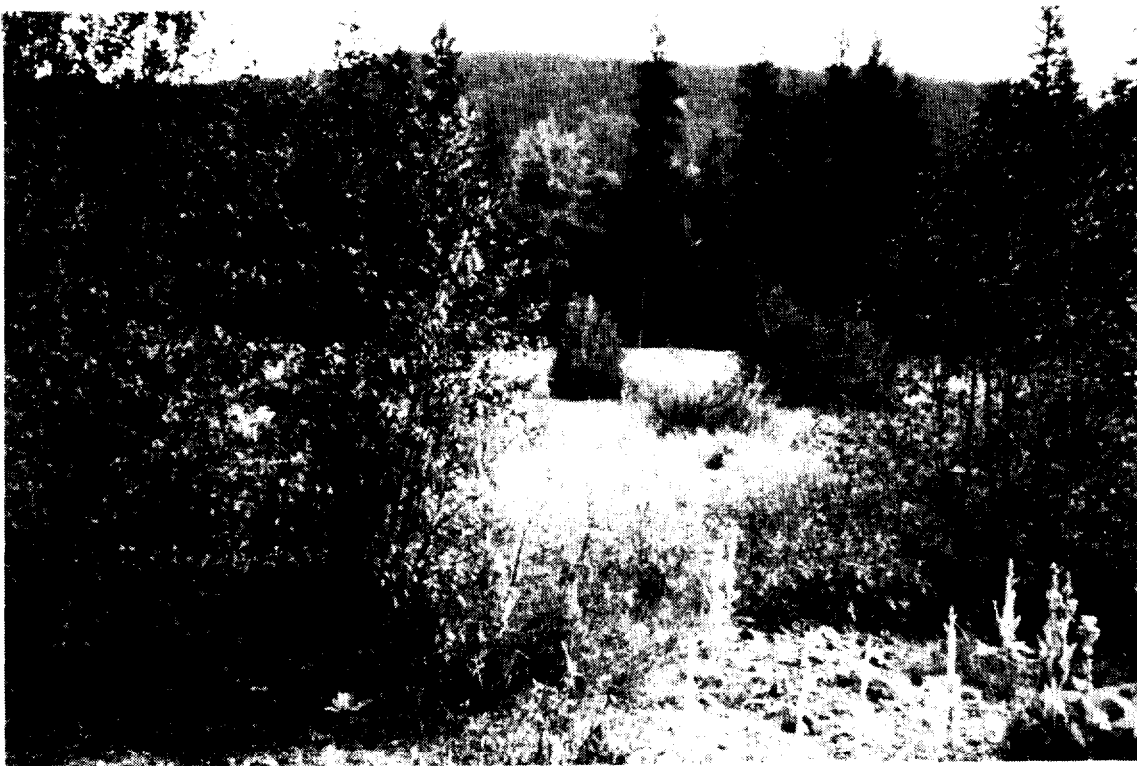
VEGETATION PHOTO POINT
 LOOKING FROM 0 FT. TO 180 FT. ALONG VEG. PLOT LINE
 RANDOM ROCKS 2 VICINITY AUGUST 30, 1990

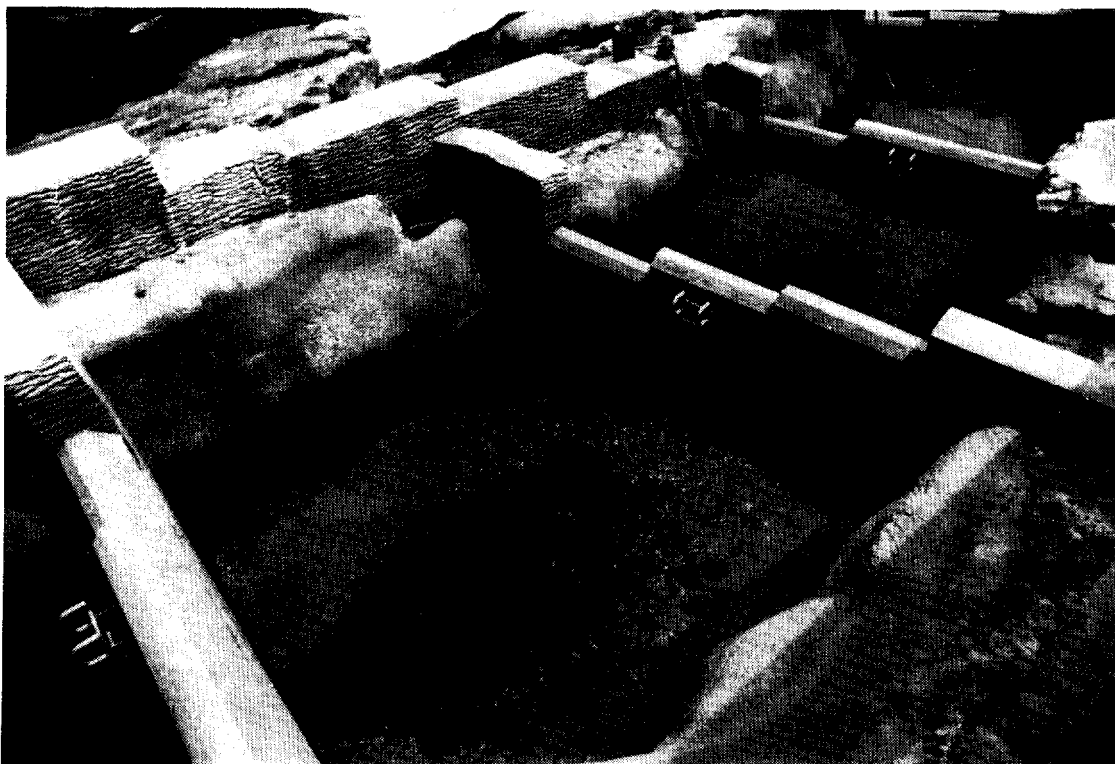
Gravel Deposits in Salmon Falls Fishway
August 1, 1989

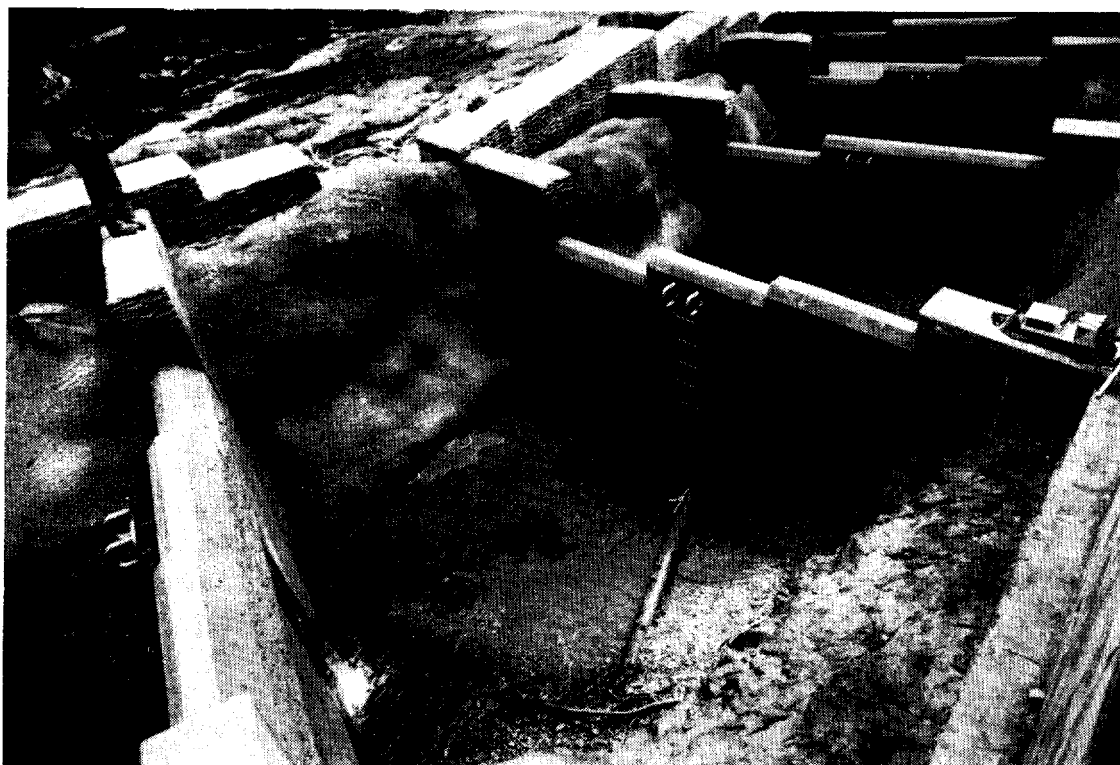
The fishway was drained on August 1st and examined for bedload accumulation and wear. The structure appears to be functioning well and no major maintenance problems were noted. Several weir orifices were blocked when gravel backed up against waterlogged debris, all but one of the orifices were unplugged within 4 hours after the fishway was drained. One of the weir orifices was not unplugged when the fishway was drained. After consultation with Washington Department of Fisheries biologists at the site, it was agreed that the fishway should not remain dewatered overnight just to unplug one orifice.

Gravel Deposits in Salmon Falls Fishway
August 1, 1989

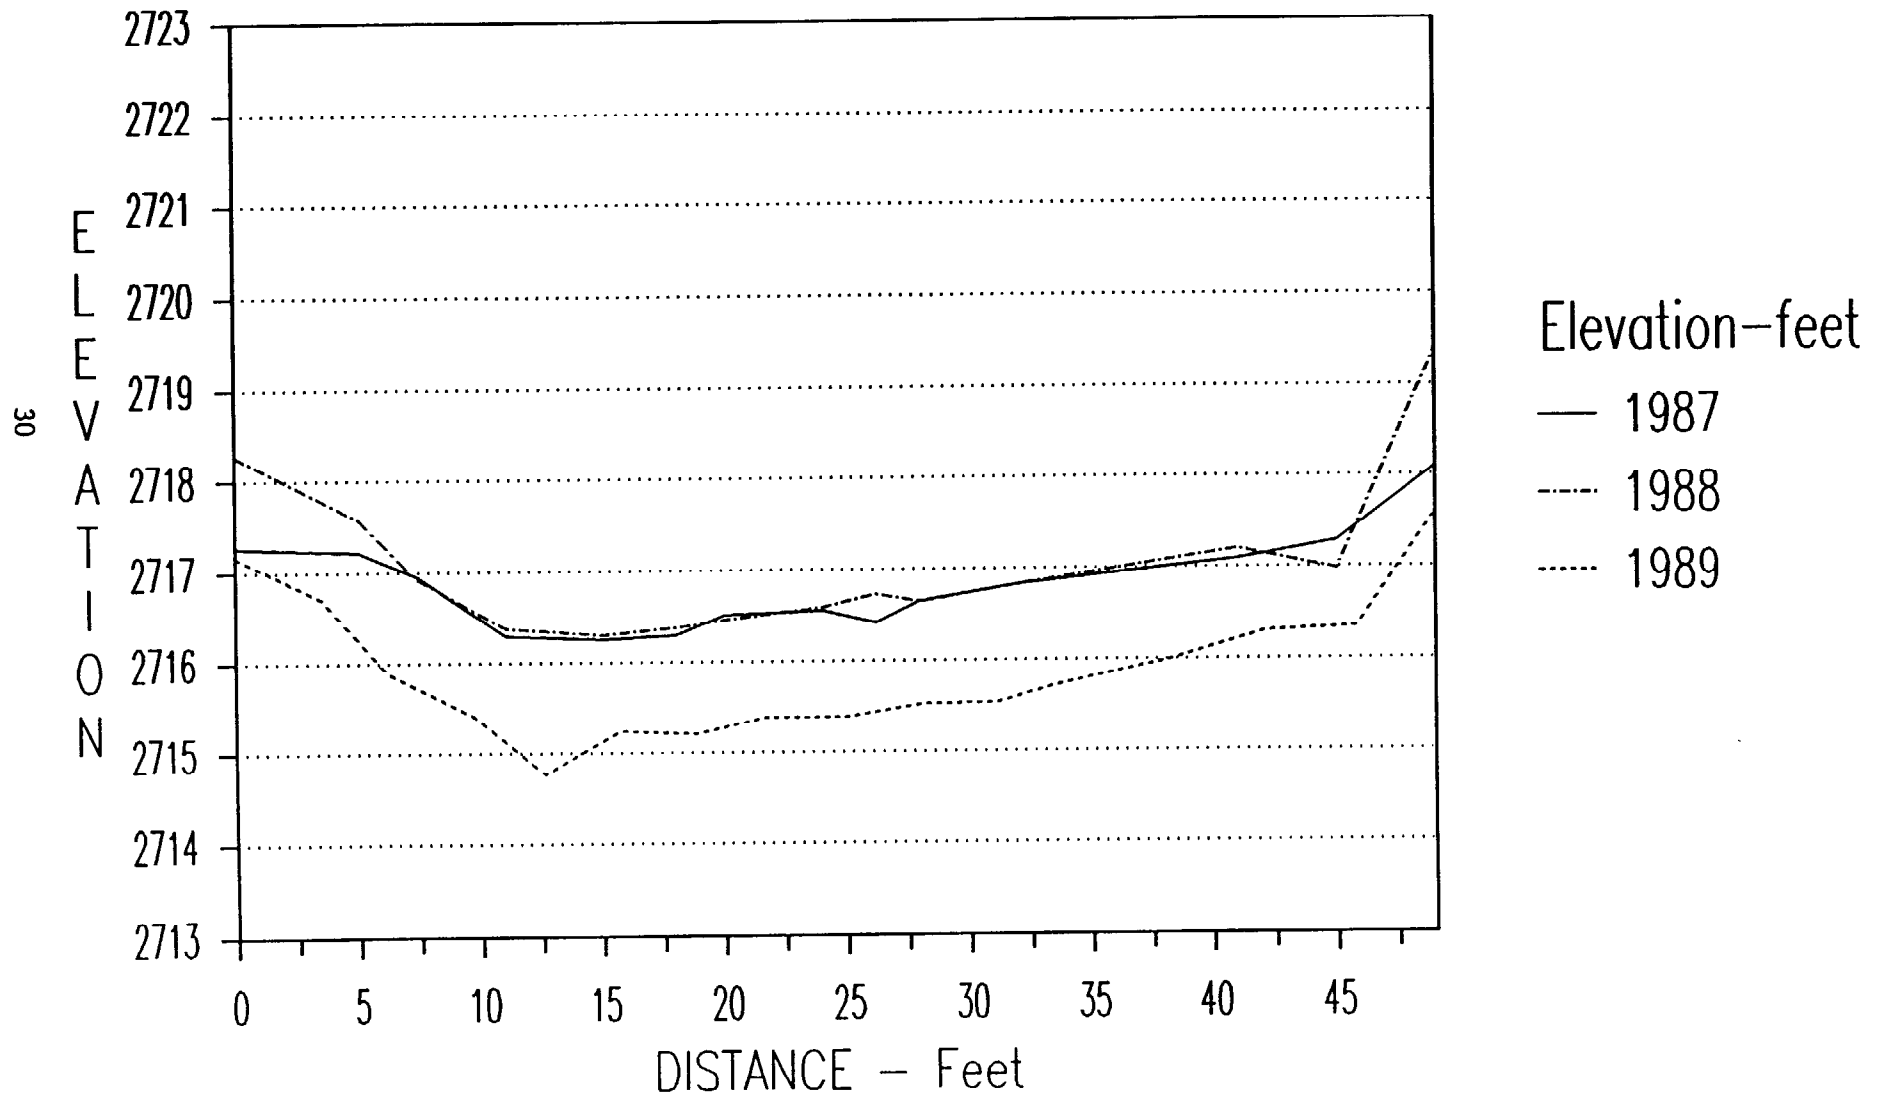
LOG SILLS

- 1) LOG SILL- The channel cross sections appear unchanged over the last two years. The 1989 elevations are approximately a foot lower than the 1988 and 1987 elevations. This is most likely an error in the field notes, as this portion of the channel does not visually appear to have changed much since the structure was installed in 1986. The last three springs have not produced large enough flood events to cause any significant channel changes.
